Manhole Inspection Summary

Manhole # S37U1_033MH

Insp Date: **8/13/08 10:55 AM**

Location Address: **Baltic Ave.**

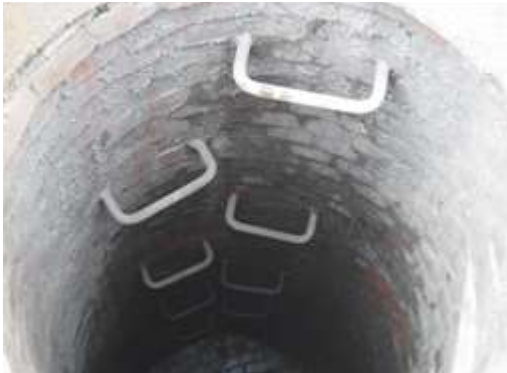
Count: **8** Missing: **0** ☐ Corroded

steps

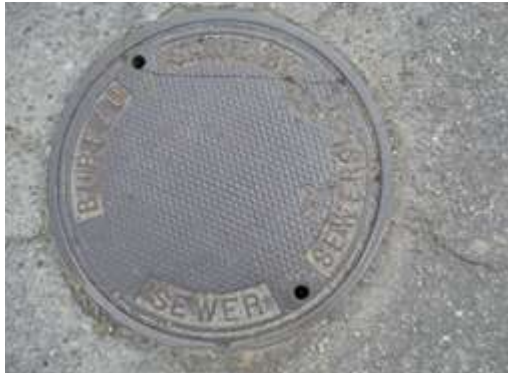
Manhole cover is cracked.

Condition: **Cracked**

Cover (cracked)

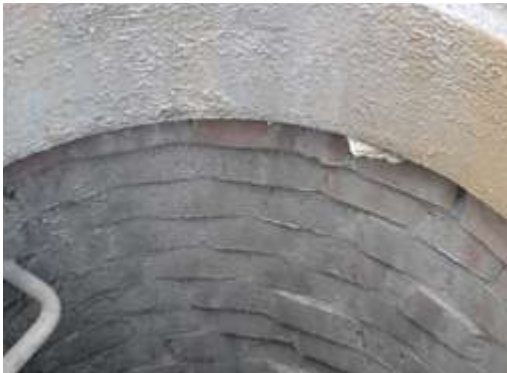
Defect 2

Offset: **2** (in.)

frame offset

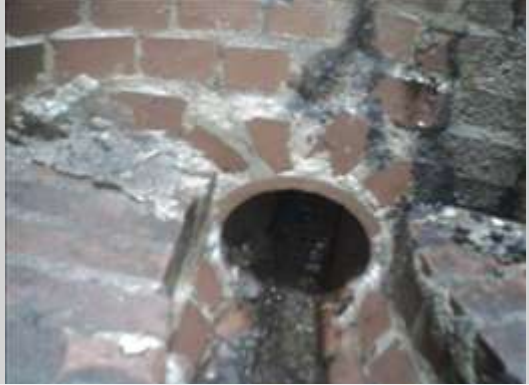
12 O'Clock Outflow

8 in. Circular Gravity Sewer
Pipe Out @ 12 O'Clock

Pipe Height: **8.4** (in.) Rod and Bar (Angled)
Pipe Material: **Clay** ☐ Pipe Lined
Invert Depth: **13.70** (ft.) Flow Characteristics: **Slow**
Deposits: ☒ None ☐ Mud ☐ Sludge ☐ Debris ☐ Grease
Silt Depth: (in.) Deposits Extent:
Infiltration: **None** Pipe Seal Cond: **Sound**

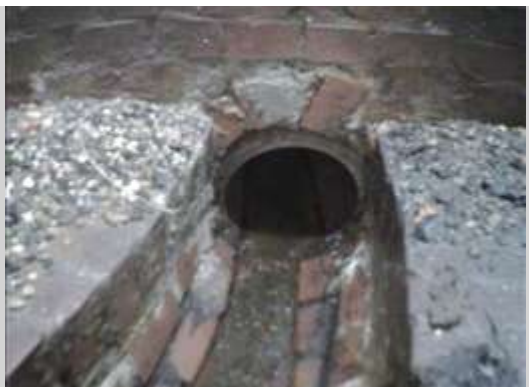
5 O'Clock Inflow

8 in. Circular Gravity Sewer
Pipe In @ 5 O'Clock

Pipe Height: **8.4** (in.) Rod and Bar (Angled)
Pipe Material: **Clay** ☐ Pipe Lined
Invert Depth: **13.70** (ft.) Flow Characteristics: **Slow**
Deposits: ☒ None ☐ Mud ☐ Sludge ☐ Debris ☐ Grease
Silt Depth: (in.) Deposits Extent:
Infiltration: **None** Pipe Seal Cond: **Sound**
